TOPAS SERVICE REPORT

CUSTOMER:	VESSEL/FACTORY/SITE:	SYSTEM TYPE:
University of Alaska Fairbanks	R/V SIKULIAQ	TOPAS PS 18
LOCATION:	SERVICE ENGINEER:	START DATE:
San Juan, Puerto Rico, At Sea	Johnny Dybedal	11/09/2014
SYSTEM MAINTENANCE ID:	ACCOUNT/JOB NO:	STOP DATE:
		21/09/2014

Perform TOPAS PS 18 SAT.

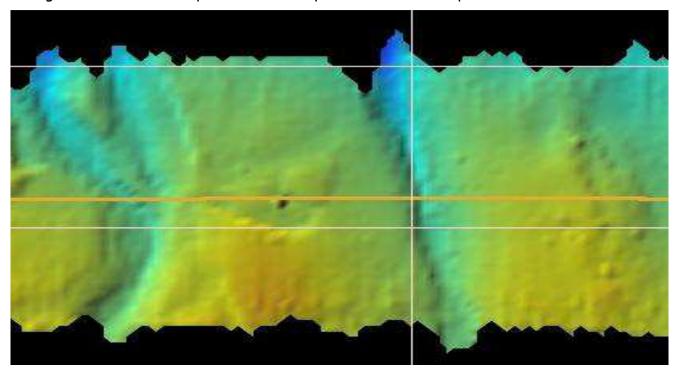
Figure 1 Bathymetry of the area where SAT was performed.

The survey line, which was followed during the operational test, is shown as the yellow horizontal line in Figure 1 below. Unfortunately, the area contained several steep slopes that are seen in the figure, which results in poor sub-bottom profiles with limited penetration.

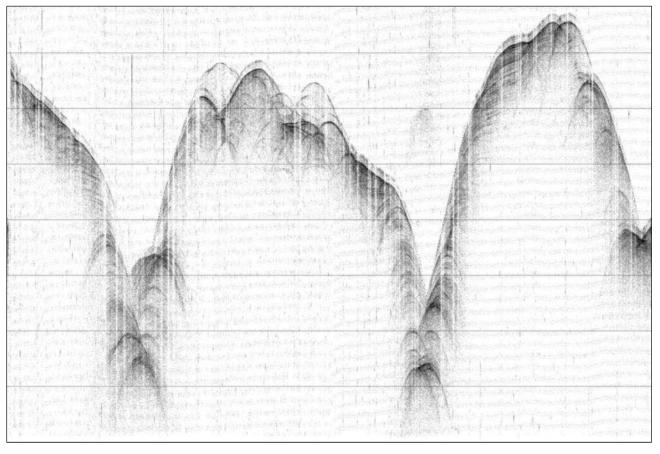
Figure 2 TOPAS data from the line.

Some weak parallel lines are seen in the figure. These lines are caused by noise bursts repeated at 8.33 ms intervals. They seem to be dependent on the status of other electrical systems on board the vessel because they are not always present.

In the noise tests performed later on, there are indications that the noise bursts is a function of engine thrust.

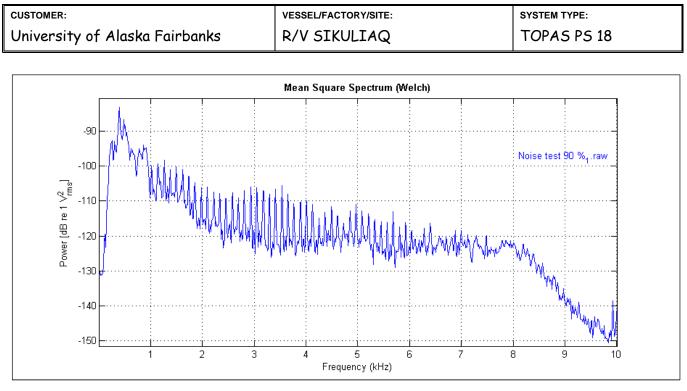
Figure 3 Power Spectral Density for noise input showing spectral lines spaced by 120 Hz.

In the power spectral density displays of noise at 90% thrust shown in Figure 3, these noise lines are shown as spectral lines with spacing of 120 Hz.

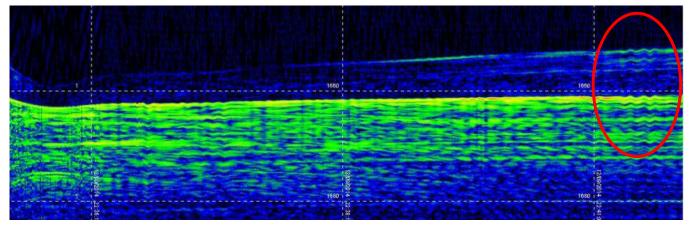
Figure 4 Result of disabling heave compensation is shown within the red circle.

Due to the good weather conditions, heave compensation was difficult to demonstrate during the SAT survey line. However, later on data was recorded in a flat area where it was possible to verify heave compensation. In Figure 4 heave compensation has been disabled on the right hand side (red circle) and it is evident that the heave movement of the vessel (or more correctly of the TOPAS transducer) influences data here.

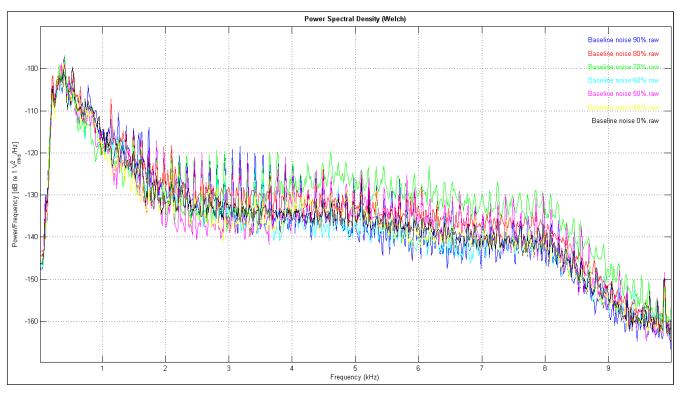
The power spectral density (PSD) curves are plotted in Figure 6 for thrusts from 0% to 90%.

The spectral noise density increases by more than 30 dB for frequencies from 2.5 kHz down to 0.5 kHz. Therefore, the recommended frequency range to be used for sub-bottom profiling is from ~2 kHz and up to 6 kHz.

Based on the results from noise measurements versus vessel thrust, it turns out that the best operational conditions are achieved for thrusts between 50% and 60%, which is equivalent to a vessel speed of 7 to 9 knots.

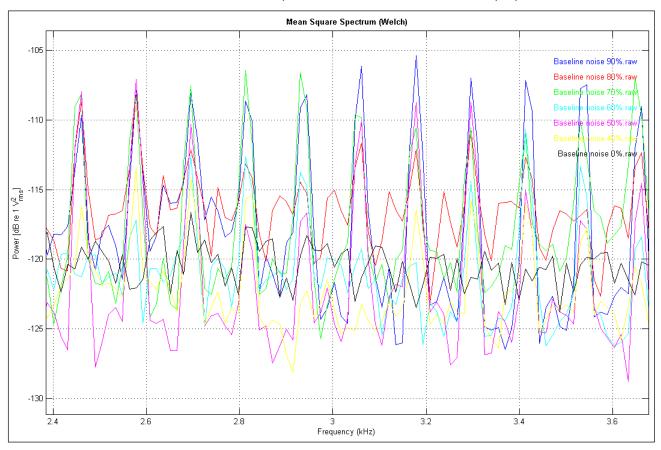
Figure 7 Details of power spectral density of received noise from 0% to 90% thrust

Figure 7 shows an expanded section of the PSD shown on Figure 6. The lines are up to 15 dB higher a 90% thrust compared to 0 % thrust.

These noise bursts are observed as line pattern in the TOPAS MMI display.

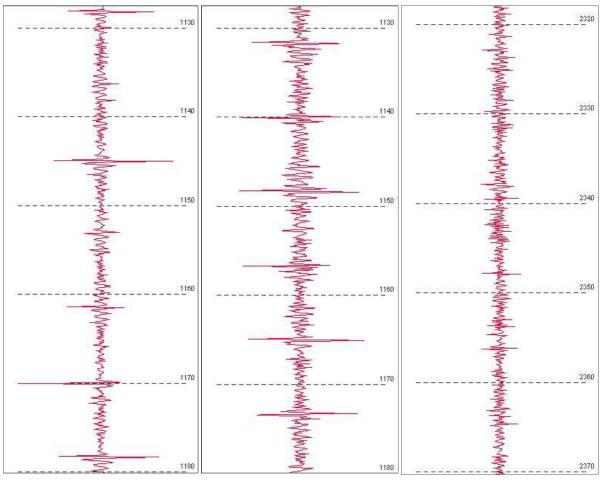
Figure 8 50 ms time traces showing 8.33 ms spaced noise bursts for the following recordings: 0% thrust, 90% thrust and part of survey line, from left to right, respectively.

The noise bursts are seen in all traces, but the level varies much: for 0% thrust, the level of the bursts varies in the trace, for 90% the level are high for all bursts but in the current survey line the bursts are considerably lower.

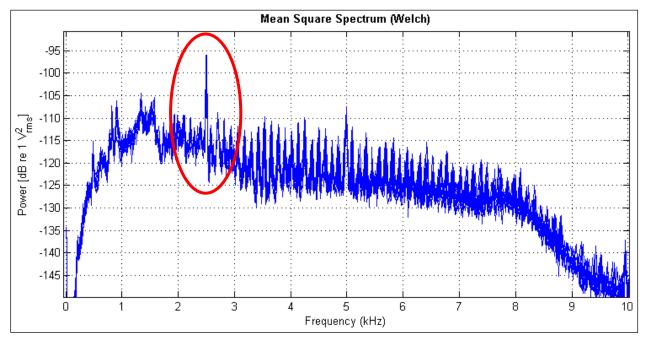
Figure 9 Spectral line at ~2.5 kHz.

During some periods, probably depending on other activities on the vessel (thruster, winch operation etc.), a frequency line at ~2.5 kHz and harmonics at 5 kHz and 10 kHz are present in the spectrum. The level at 2.5 kHz is approximately 20 dB higher than what was expected in the same frequency band, see Figure 9.

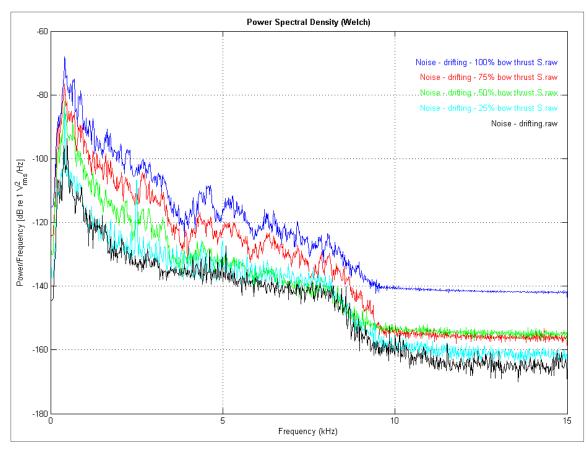
Figure 10 PSD of noise level at different bow thruster levels.

Noise recording on the TOPAS system was also done during noise test of bow thruster. F shows PSD of the noise level at 0%, 25, 50%, 75% and 100% thrust, respectively.

Noise level at 25% will not influence the TOPAS data quality significantly. However, higher thrusts will degrade the data and even mask the data completely!

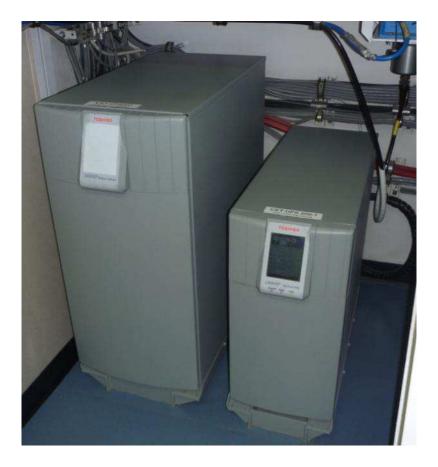
The main power to the TOPAS and EM system is supplied from a 10 kVA UPS unit with battery backup, see Figure 11. The unit is configured to supply 240 VAC at 60 Hz. However, the LCD display shows that the output voltage at one time was only 212 VAC, see Figure 12. The average output power was ~1.5 kVA and peak currents indicated was up to 11 Amps.

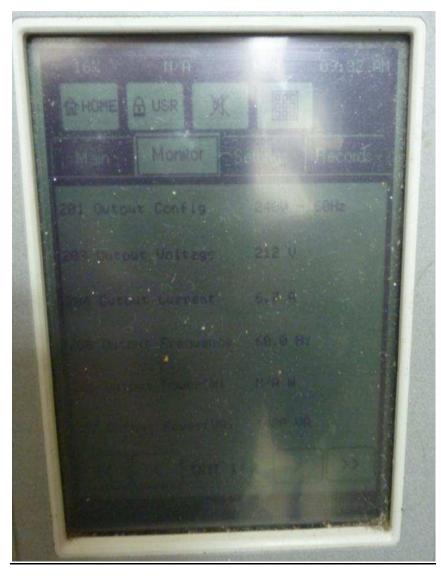
Figure 12 LCD display on UPS showing configuration and status.

Level seems to vary between 211 and 214 VAC.

Supply voltage for the transceiver was in the lower range; 211 - 214 VAC. The problem was due to wrong UPS configuration; fixed and currently voltage is 238 VAC.

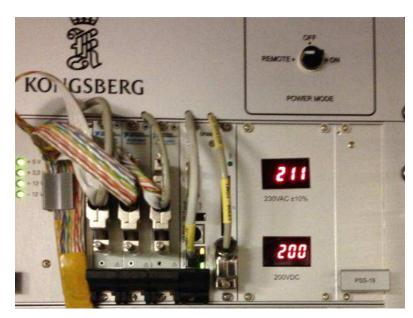
Figure 13 Input AC voltage meter (top) in TOPAS transceiver.

During inspection of the TOPAS transceiver, the built-in meter showed 211 VAC, see Figure 13. At the same time, the display on the UPS unit also indicated an output voltage of 211 VAC.

This level is very low and the reason for this should be investigated.

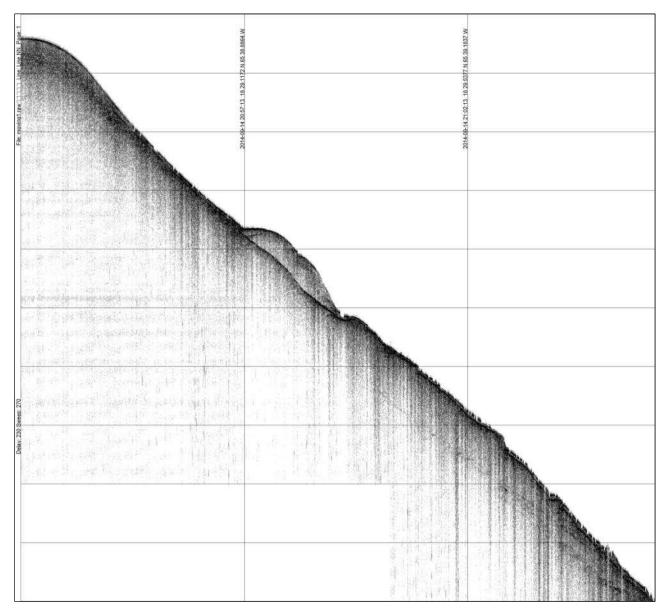
Figure 14 Example of slump. Vertical scale is ~20 meter per division.

First, Figure 14 shows a nice example of a profile crossing a slump during transit to deeper waters is shown. The length of the slump is approximately 335 meters and the maximum thickness is about 13 meters assuming sound speed of 1,500 m/s. Water depth is 250 meters.
